DYNAMIC SCIENCE, INC.
In-Depth Accident Investigation

Case DSI-94-SB-08

TECHNICAL SUMMARY

**DYNAMIC SCIENCE, INC.
ACCIDENT INVESTIGATION
CASE NUMBER: DSI-94-SB-08**

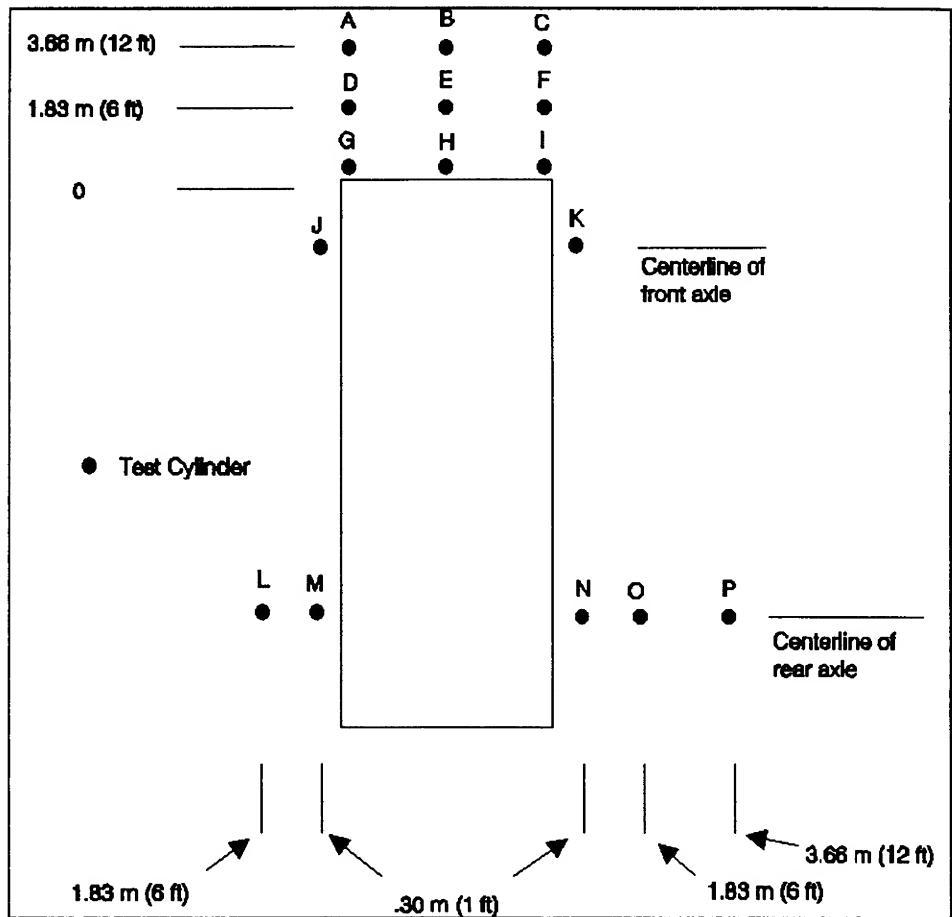
Figure 1. Location of Test Cylinders for School Bus Field-of-View Test

The school bus field-of-view test was conducted using orange test cylinders measuring 0.3048 m (1 ft.) high and 0.3048 m (1 ft.) in diameter. The test cylinders were positioned as depicted in Figure 1. All exterior mirrors had been repositioned prior to inspection (the bus had been repainted), but the test was conducted nonetheless.

The following table shows which test cylinders were visible using a given mirror as seen through the camera. The shaded areas represent test cylinders which were not visible using any of the mirrors.

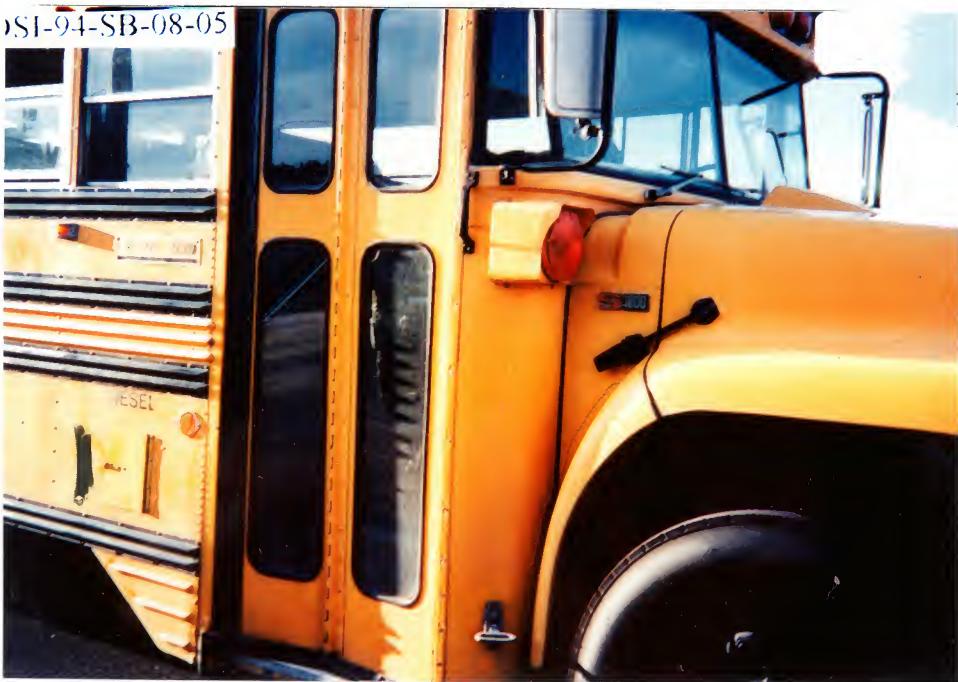
DSI-94-SB-08-05

PHOTO NO.	VEHICLE NO.	DIRECTION OF PICTURE	SUBJECT MATTER
1	1	East	Area of impact and final rest.
2	1	West	Final rest. Note: Vehicle was moved by the driver approximately 30 feet after the accident.
3	1	West	Final rest.
4	1	NA	Orienting view of bus.
5-8	1	NA	Close-up views showing scuff marks from contact with case subject.
9	1	NA	Orienting shot showing entangled strap.
10-12	1	NA	Entangled strap.
13	1	NA	Scuff marks from case subject.
14	1	NA	Overview of step well, handrail.
15-17	1	NA	Closeup views of entangled strap.
18-21	1	NA	Closeup views of strap in relation to case subject's backpack.

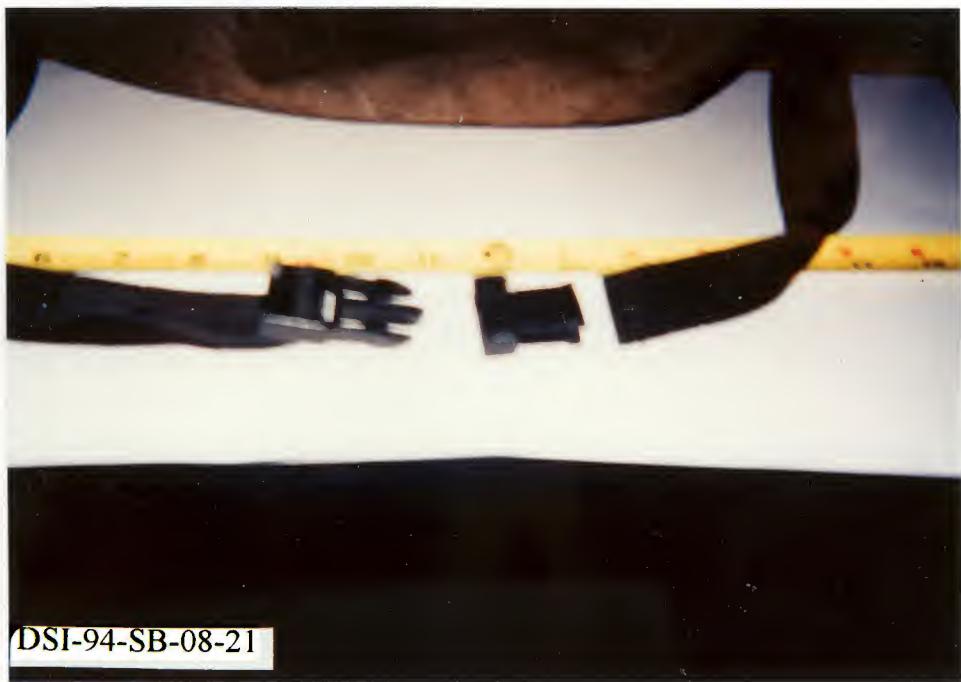
DSI-94-SB-08-21

The 12 year old case subject was wearing a blouse and a skirt, and had both her arms through the arm straps of the backpack she was wearing. The waist straps were not fastened. The right side strap slipped into the gap between the floorboard and the grab rail mounting bracket. The door of the bus closed and it began its forward motion. The case subject would have been pulled off her feet in a clockwise direction with her head facing east. There was evidence along the side of the bus that the case subject was initially pulled into the side of the bus before the the strap broke and she fell to the ground where she was run over by the right rear dual tires.

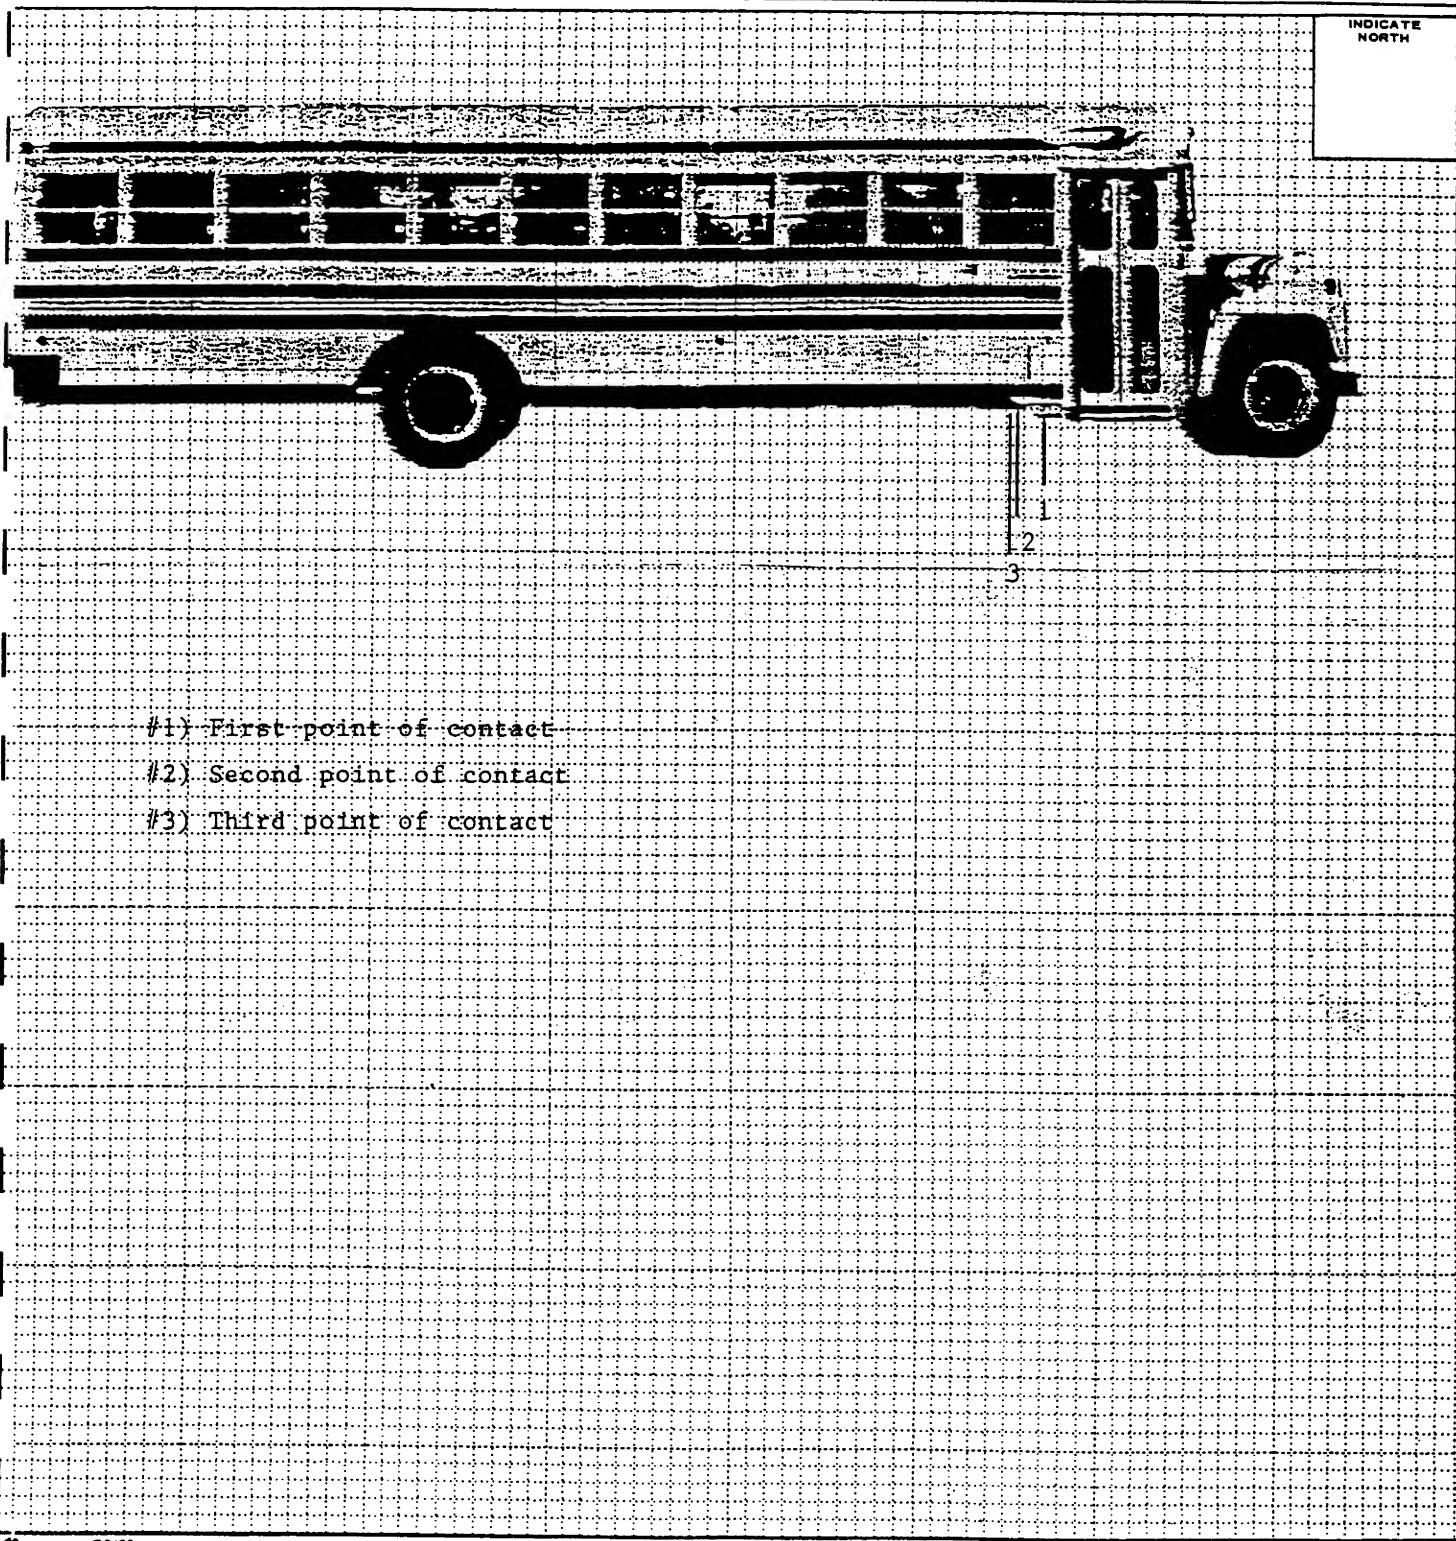
ACCIDENT DIAGRAM

- #1) First point of contact
- #2) Second point of contact
- #3) Third point of contact
